Monitoring Data Record

Project Title: U-2524AB Site 28 COE Action ID: 200321137

Stream Name: UT to Hickory Creek DWQ Number: 030909

Year 3 Winter – January 2008

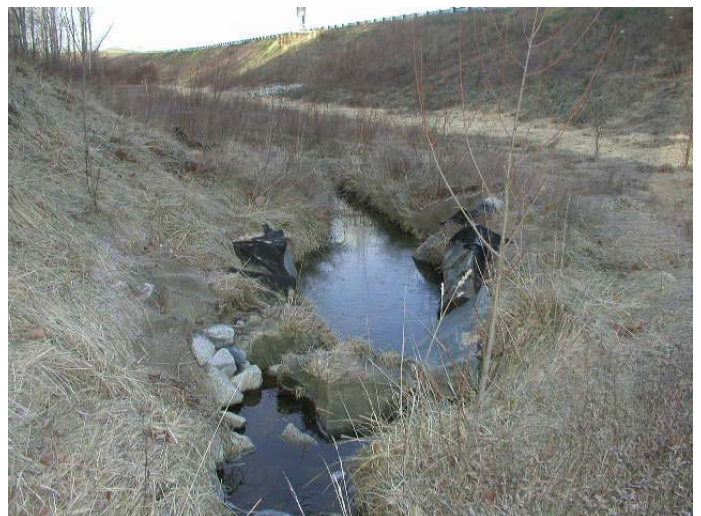
Photo Point #6 (Downstream)

This is the Year 3 winter evaluation for this stream relocation. The channel is stabilized throughout the stream relocation. The headcut at the crossvane (PP #6 Downstream) that was previously noted at Sta. 30+00 – 40SBREV- has been partially repaired and is currently stable. The channel bed behind the crossvane needs to have material added to the existing bed rock to force the water to flow across the top rock in the channel bed. This work should take place soon. NCDOT will continue to monitor this stream relocation.

Date Inspected	Sta. 30+00 – 40SBREV-	Station Number	Station Number	Station Number	Station Number
Structure Type	Crossvane				
Is water piping through or around structure?	Water is piping around crossvane				
Head cut or down cut present?	Headcut				
Bank or scour erosion present?
